**REMOVAL PROGRAM
PRELIMINARY ASSESSMENT/
SITE INVESTIGATION REPORT
FOR THE
BATES MILL SITE
LEWISTON, MAINE
10 TO 11 MARCH 1998**

U.S. Environmental Protection Agency
Region I
Emergency Planning and Response Branch
John F. Kennedy Federal Building
Boston, MA 02203

Roy F. Weston, Inc.
Superfund Technical Assessment and Response Team
217 Middlesex Turnpike
Burlington, MA 01803

April 1998

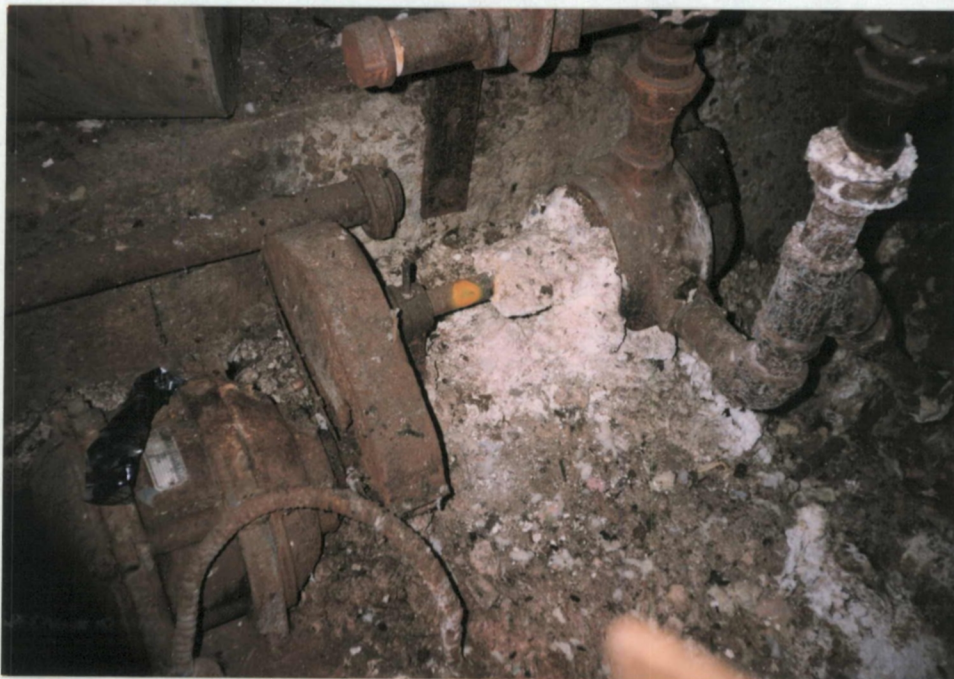
SCENE: View of sample station F-3. Suspected asbestos-containing material (ACM) on gearshaft, along south wall of basement level of Mill No. 4/Bleachery.

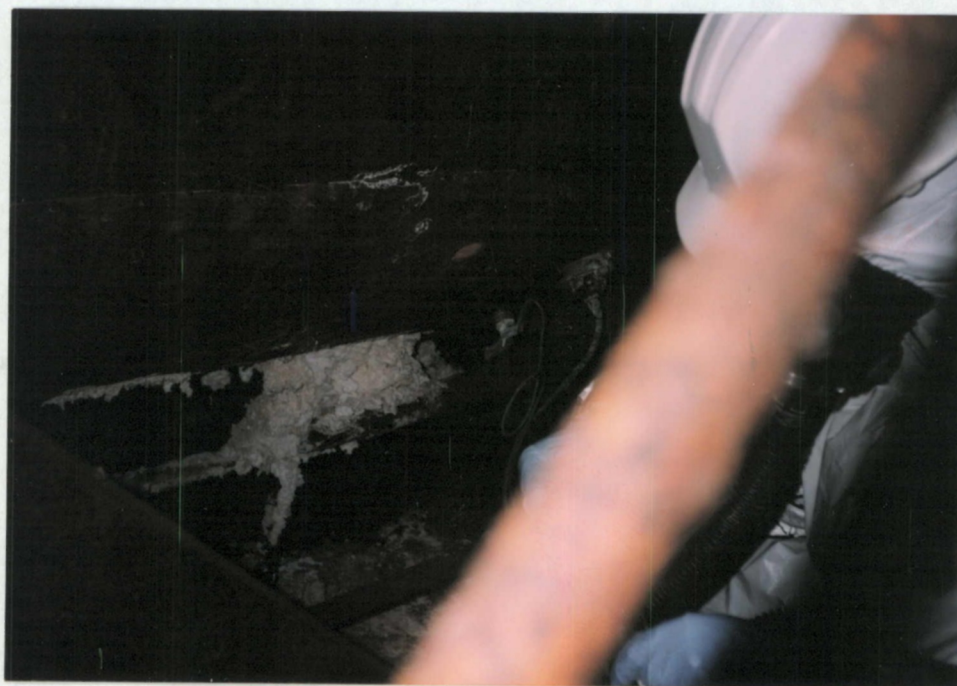
SCENE: View of sample station F-2. Crystalline white precipitate on underside of "railroad" tank car, easternmost tank car at the basement level of Mill No. 4/Bleachery.

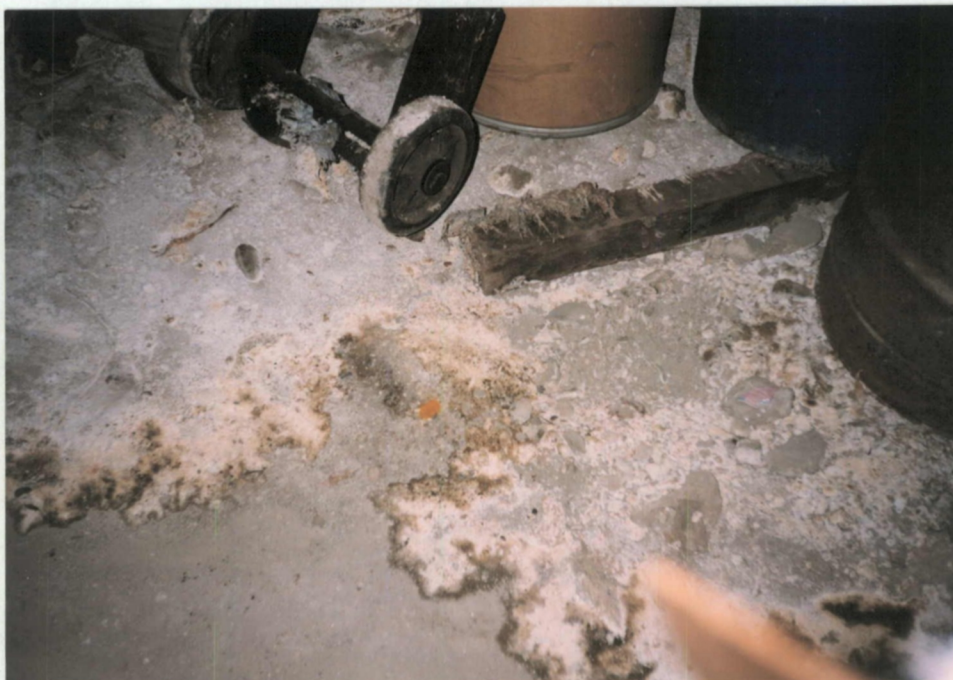
SCENE: View of sample station F-1. White, chunky solid, suspected ACM material on basement floor of No. 1 Storehouse.

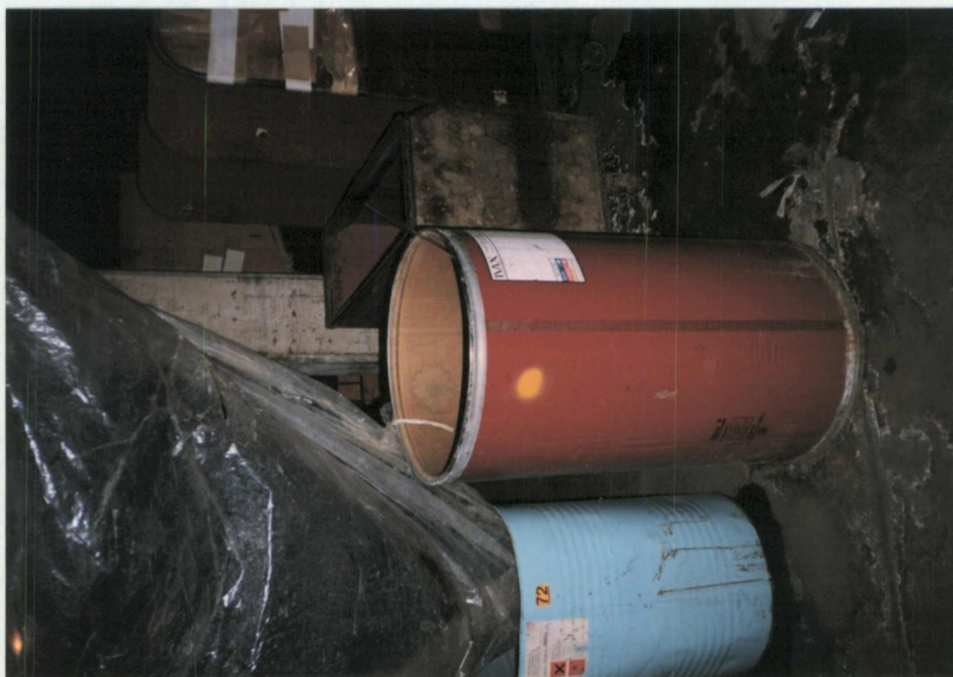
SCENE: View of sample station D-1. Red fiber drum, approximately 55-gallons, used for catching liquids dripping from ceiling and floor(s) above. Located at first floor of No. 1 Storehouse (center of room).

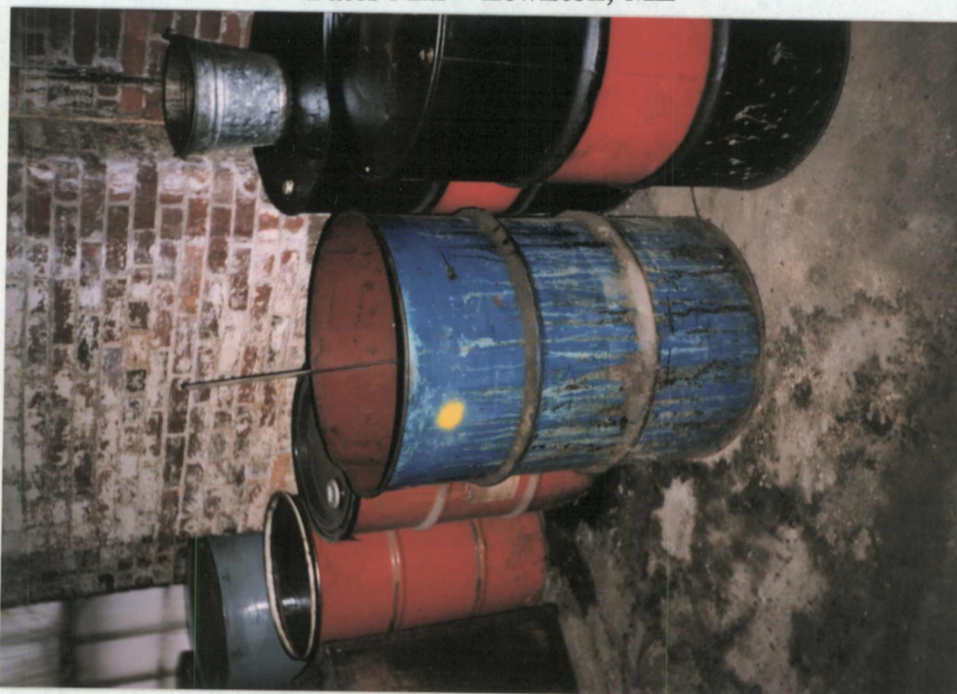
SCENE: View of sample station D-2. Blue, open-top 55-gallon steel drum, at least half full with oil or an oily liquid, located on first floor of No.1 Storehouse, along west wall.

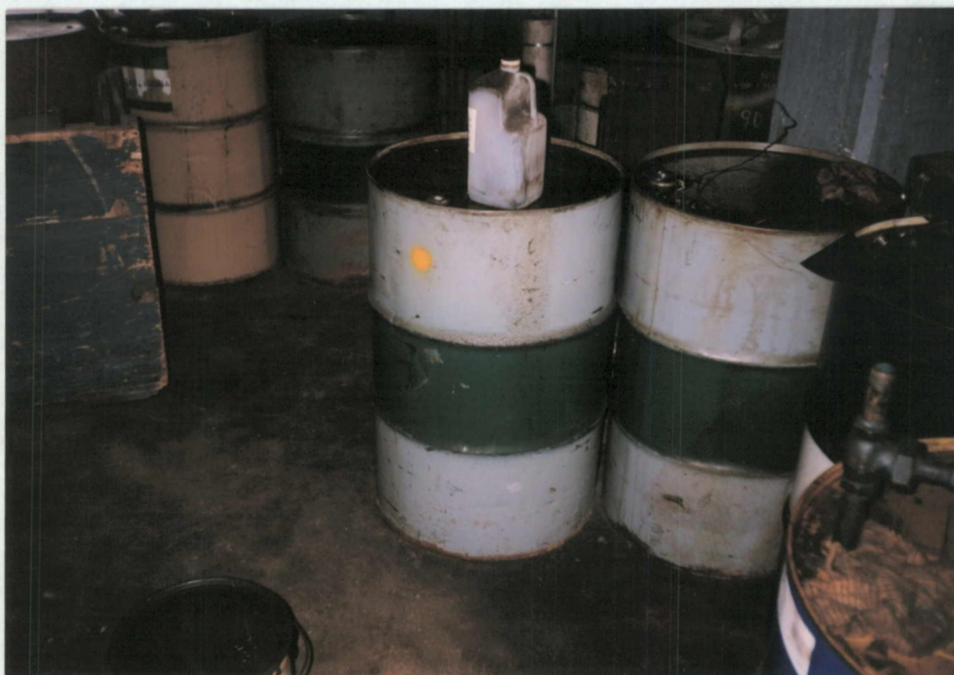
SCENE: View of sample station D-3. Grey/Green/Grey 55-gallon , closed-top steel drum, with contents, located on second floor of No.1 Storehouse, at the southwest portion of the room.

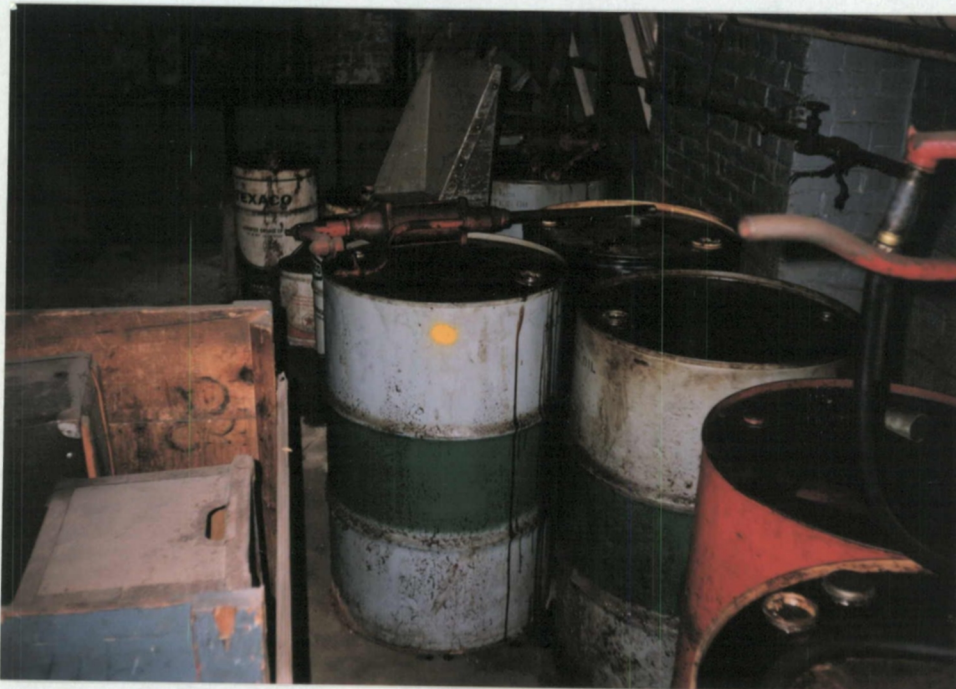
SCENE: View of sample station D-4. Grey/Green/Grey 55-gallon, closed-top steel drum, with contents, located on second floor of No.1 Storehouse, at the southwest corner of the room along the west wall (south of sample station D-3).

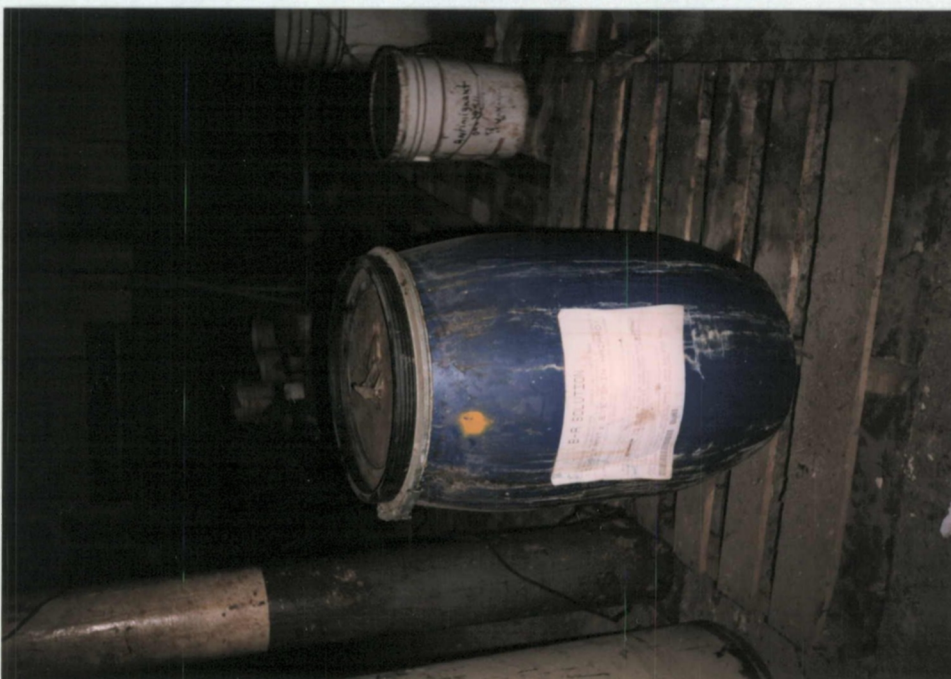
SCENE: View of sample station D-5. Blue, closed-top 55- gallon (approximate) plastic drum, with contents, located on the third floor of No.1 Storehouse, in a separate room at the southwest portion of the third floor. Labeled as B-A Solution.

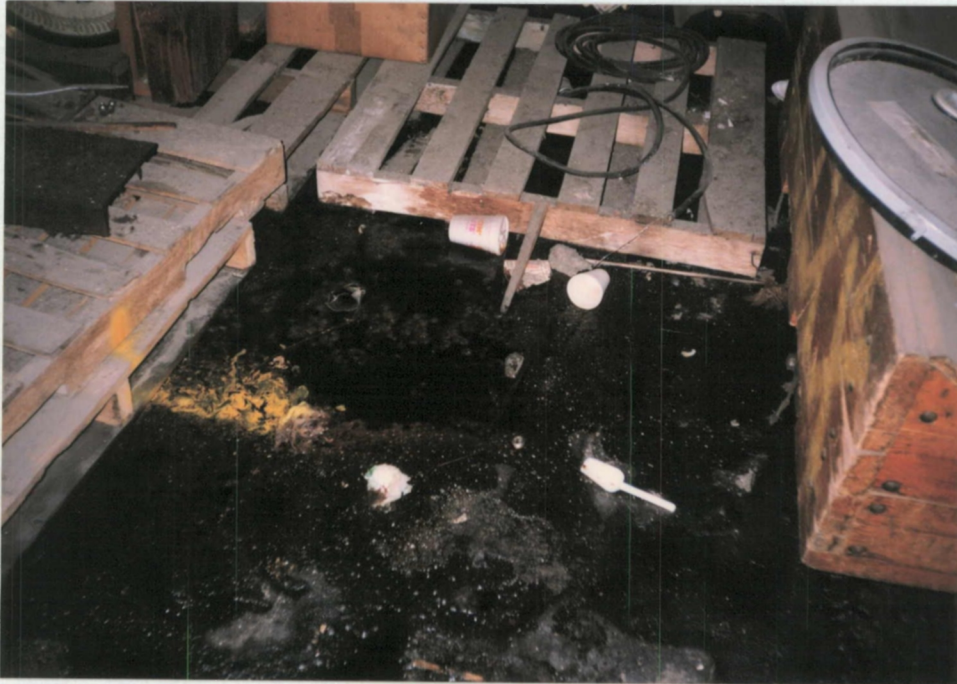
SCENE: View of sample station F-4. Puddle of watery oil, dark color, located on third floor of No.1 Storehouse at the southeast portion of the room.

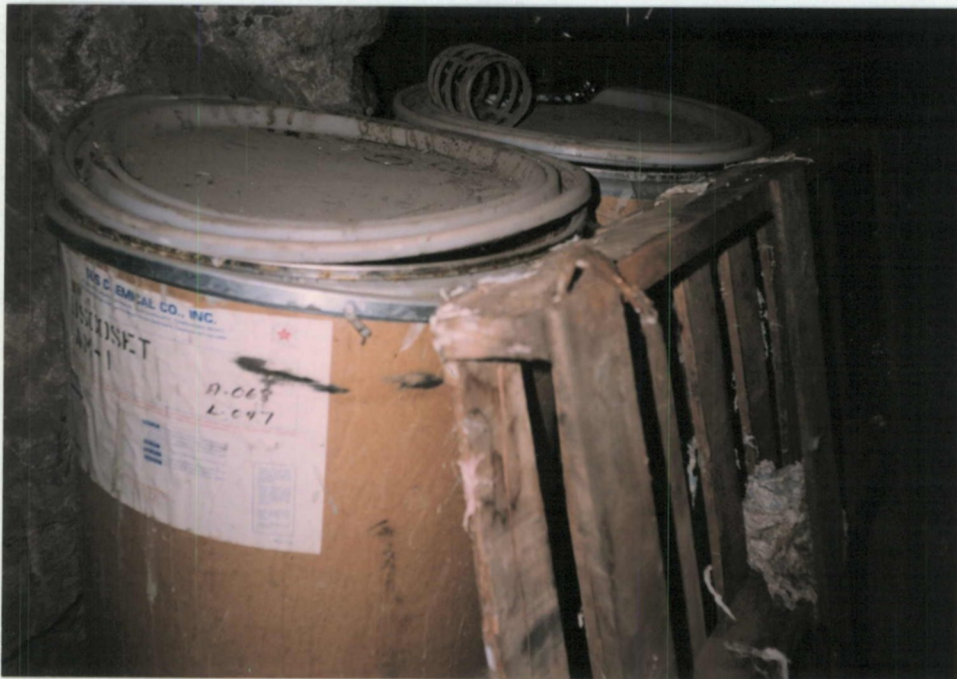
SCENE: View of two 55-gallon fiber drums, with contents, along the north wall of the basement of No.1 Storehouse. Labeled as USCOSSET-AM-1, contains formaldehyde.

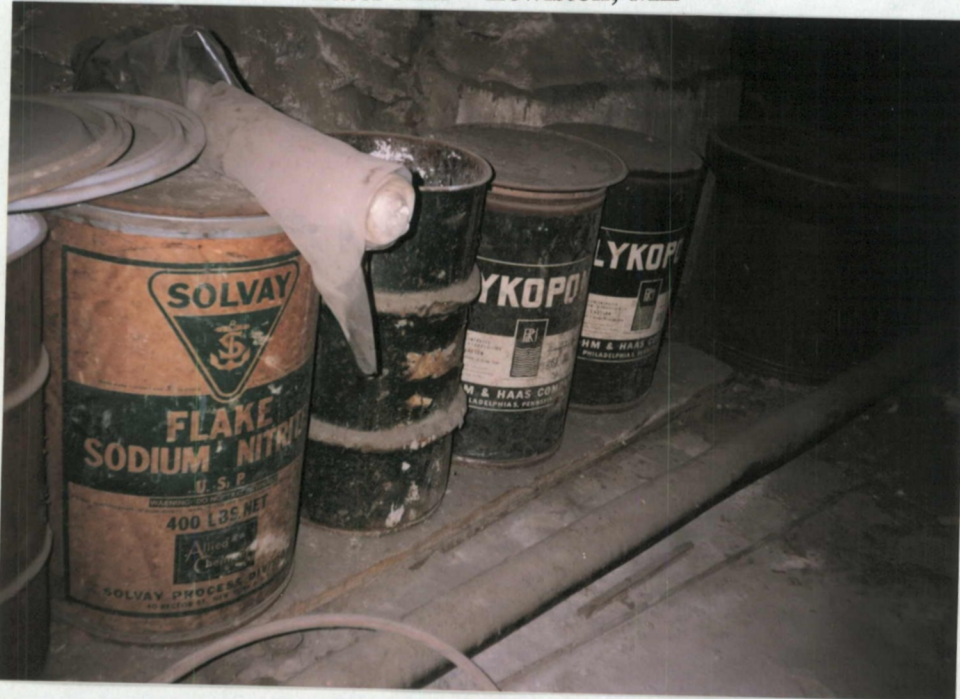
SCENE: View of miscellaneous drums, with contents, in the No.1 Storehouse, along the north wall at the northeast portion of the basement level. Drum in foreground labeled as flake sodium nitrate. Drums in rear labeled as Lykopen, concentrated sodium hydrosulfite.

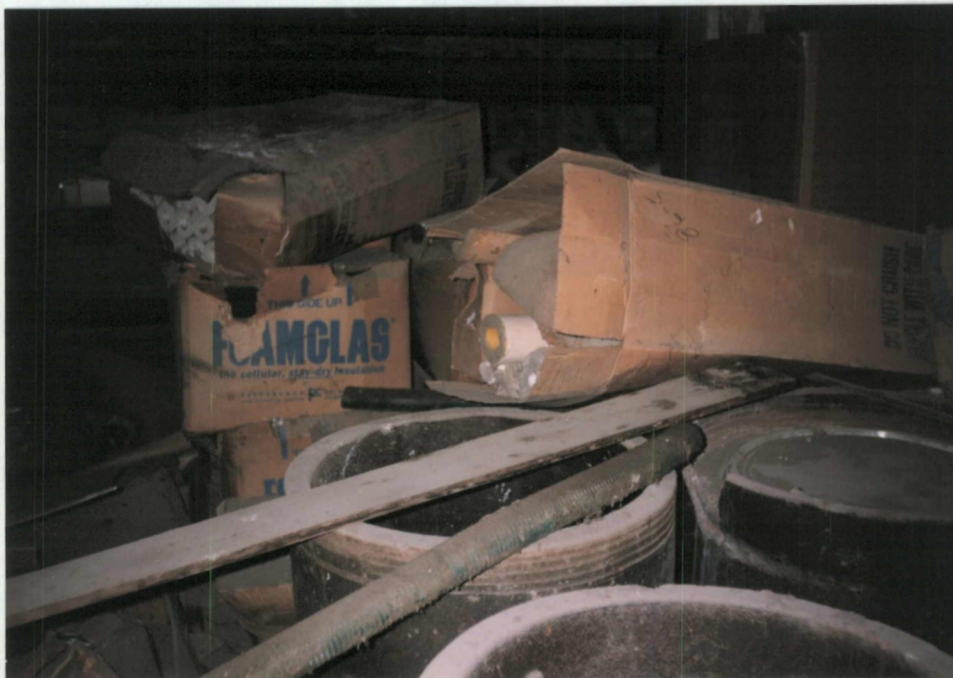
SCENE: View of boxes of suspected ACM pipe insulation, on the basement level of No.1 storehouse, northeast portion of the basement.

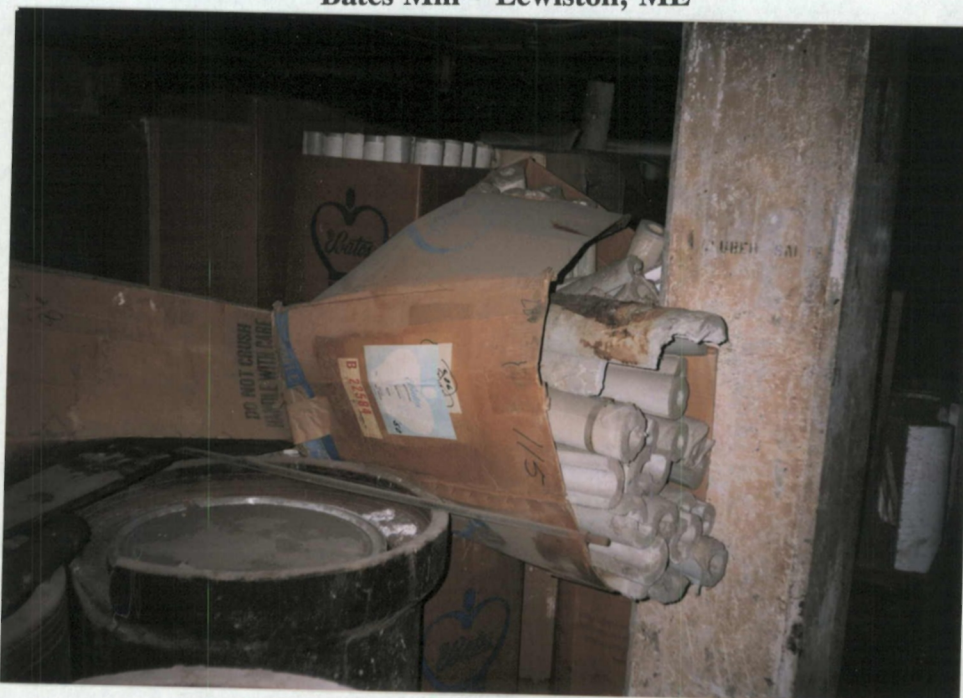
SCENE: View of numerous boxes of suspected ACM pipe insulation, on the basement level of No.1 Storehouse, easternmost half of the basement.

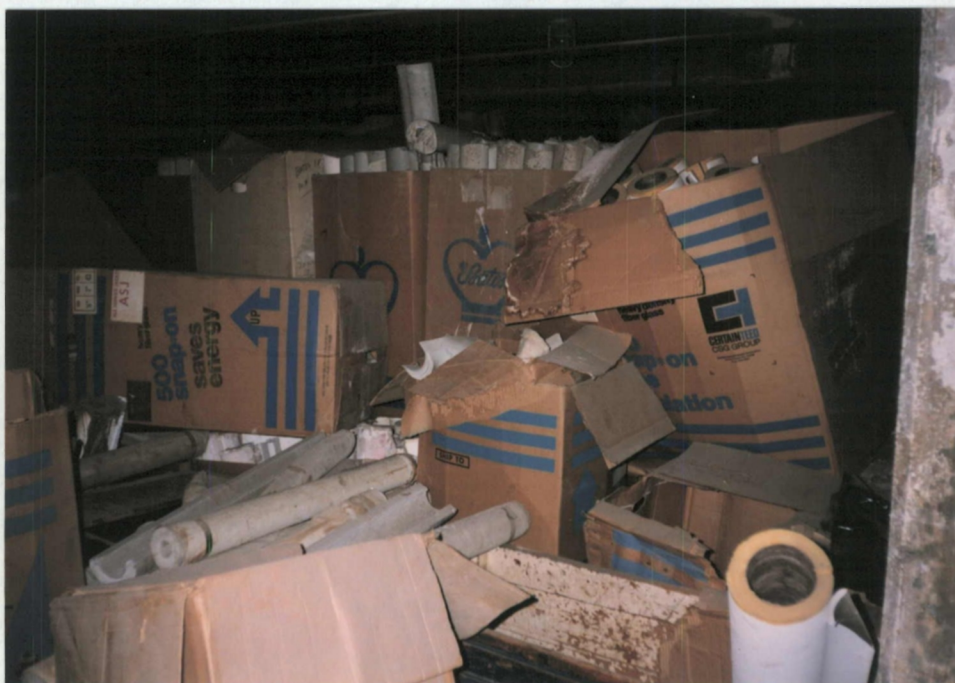
SCENE: View of boxes of suspected ACM pipe insulation, basement level of No. 1 Storehouse, eastern portion of the basement.

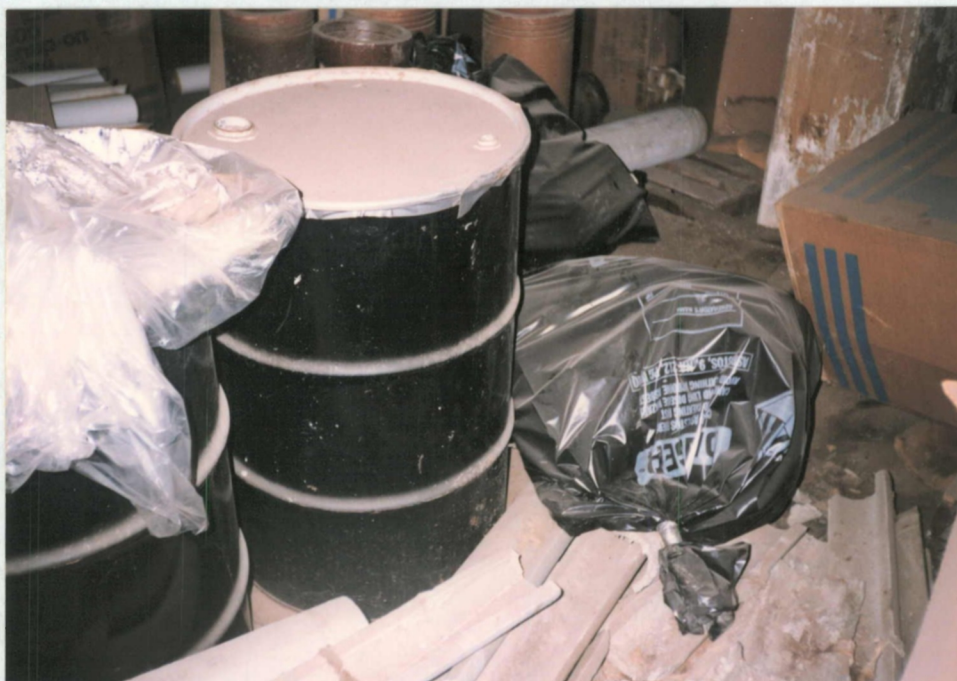
SCENE: View of two black, closed-top, 55-gallon steel drums with contents, and a plastic bag which is taped closed and is labeled "Asbestos...class 9", located at the eastern portion of the basement level of No.1 Storehouse.

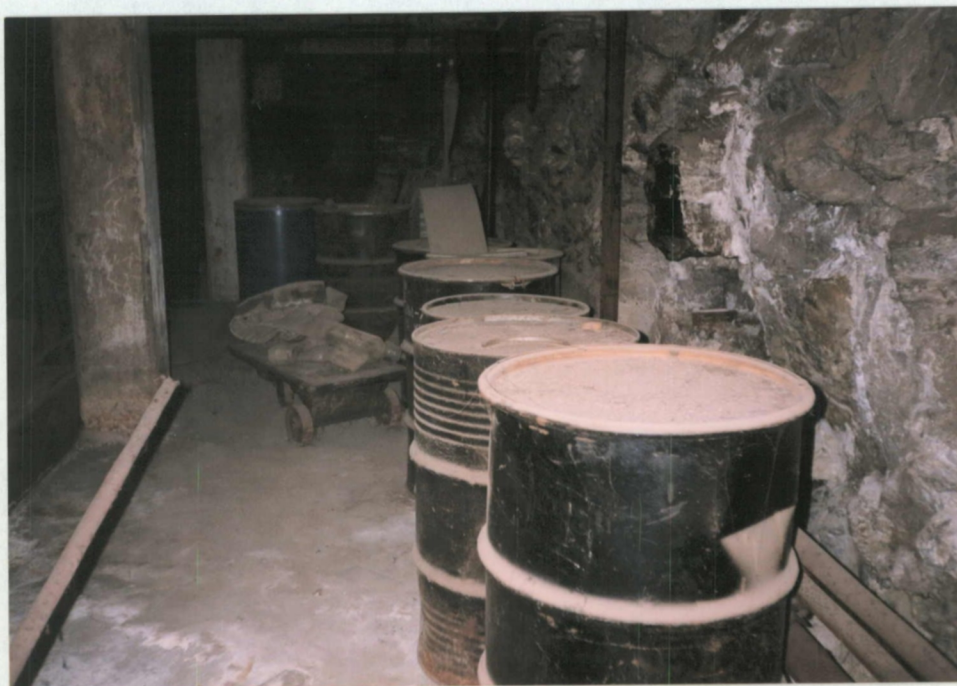
SCENE: View of miscellaneous drums along the west wall of the basement level of No.1 Storehouse.

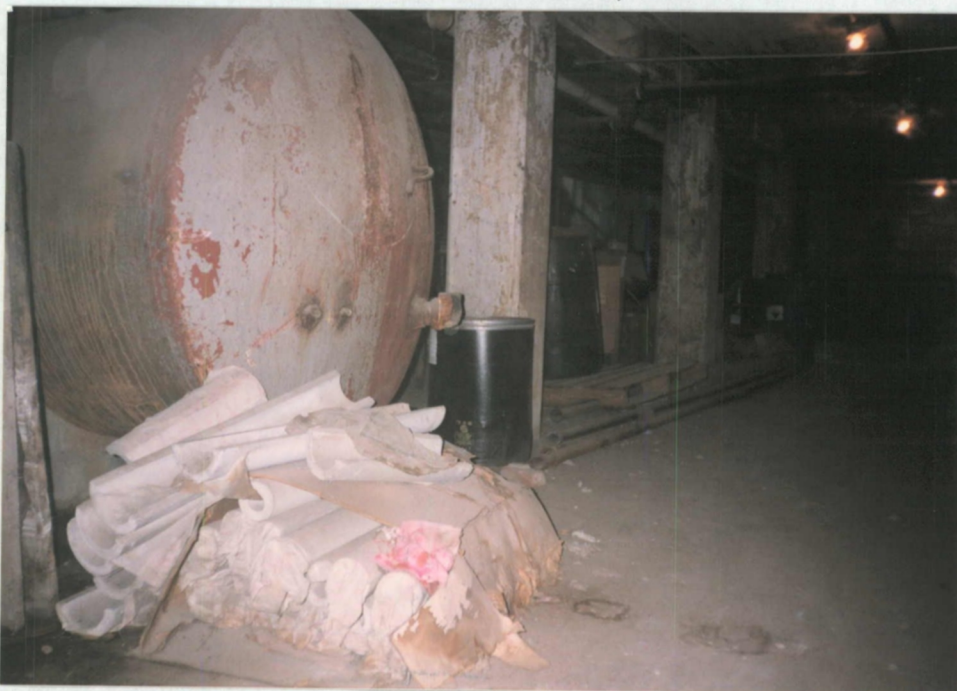
SCENE: View of a single 10,000 gallon (approximate) above ground storage tank (AST) located on the basement level of No.1 Storehouse, status of the contents in the tank (if any) are unknown. A pile of suspected ACM pipe insulation is located next to the tank. This area is located in the southwest portion of the basement.

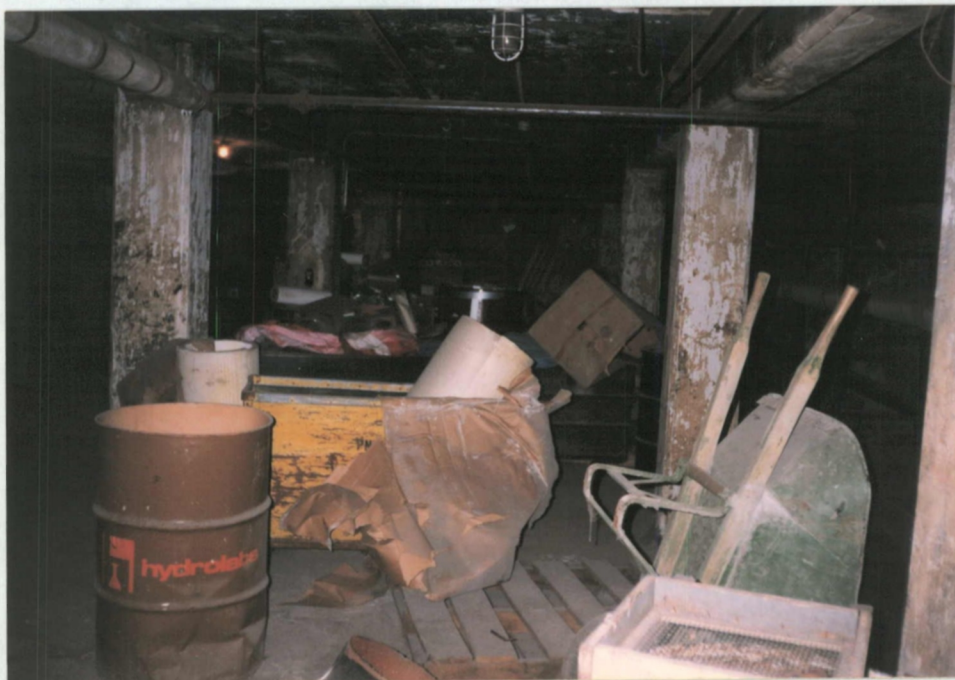
SCENE: View of the southeastern portion of the basement level of No.1 Storehouse, looking north, with drums and boxes of suspected ACM visible.

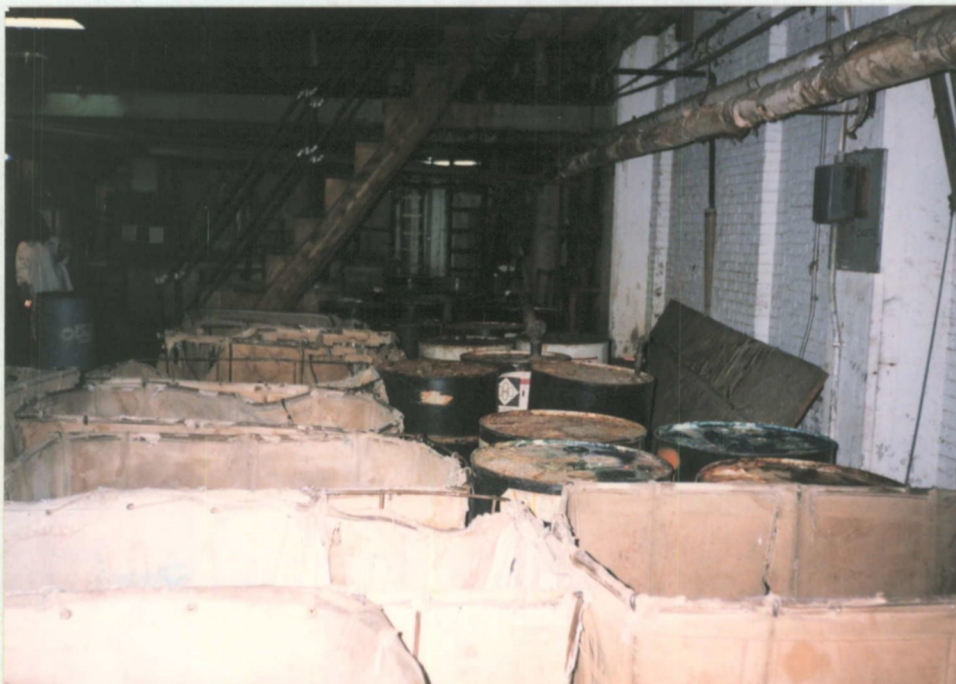
SCENE: View of miscellaneous 55-gallon closed-top steel drums, located on the first floor of the Mill No.4/Bleachery , along the south wall, looking east. Some of the drums labeled as dyes and germicides.

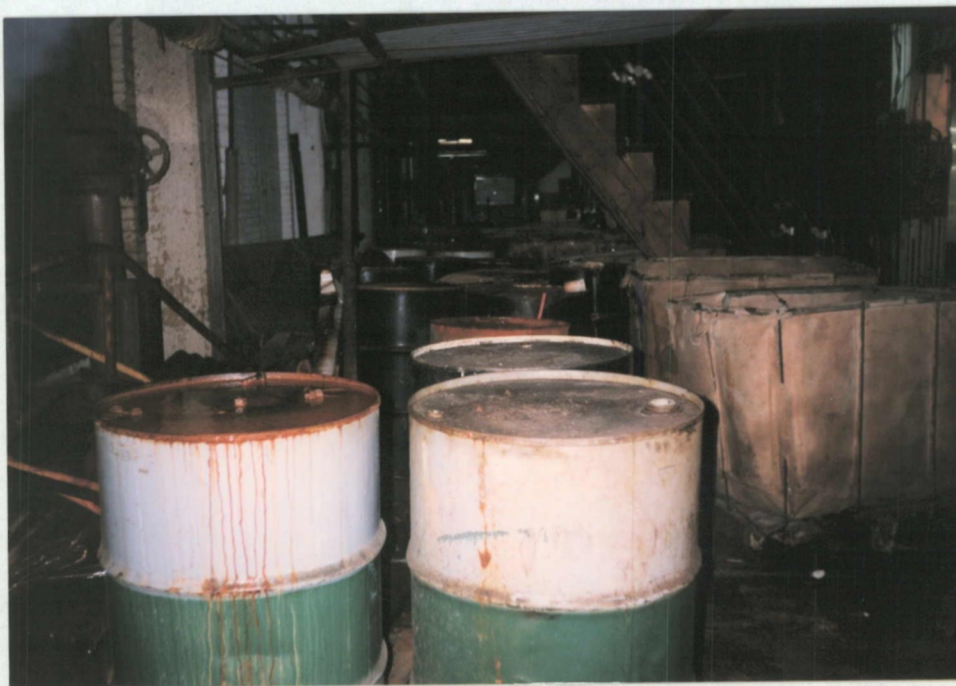
SCENE: View of miscellaneous closed-top 55-gallon steel drums, located on the first floor of Mill No.4/Bleachery, along the south wall, looking west. Some of the drums labeled as dyes and germicides.

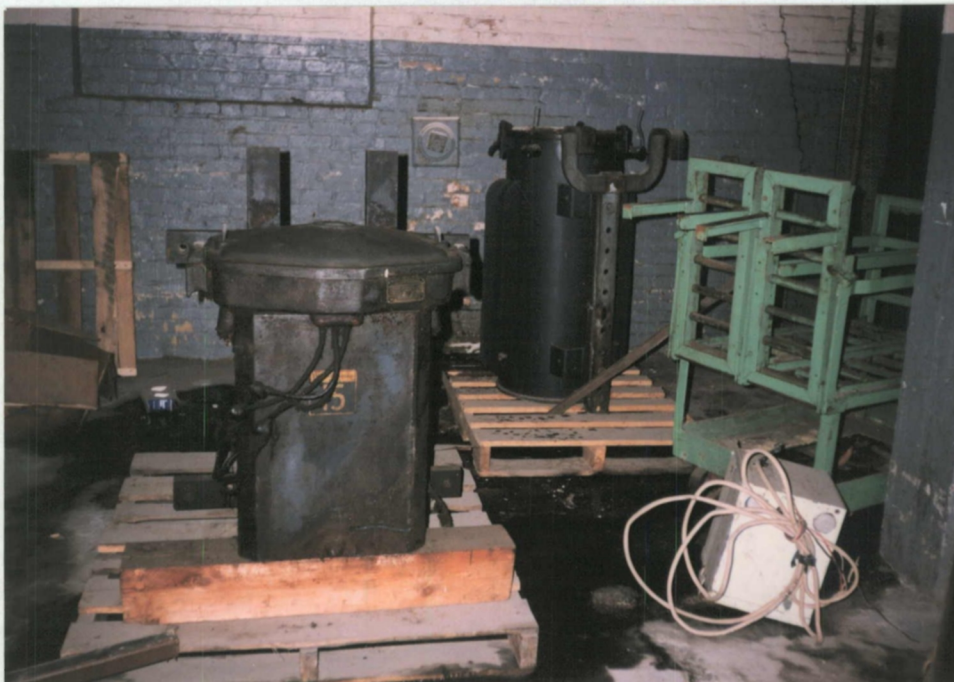
SCENE: View of two off-line electrical transformers possibly containing oil with polychlorinated biphenyls (PCBs), located at the southeastern portion of the second floor of No. 1 Storehouse, near the stairwell entryway.

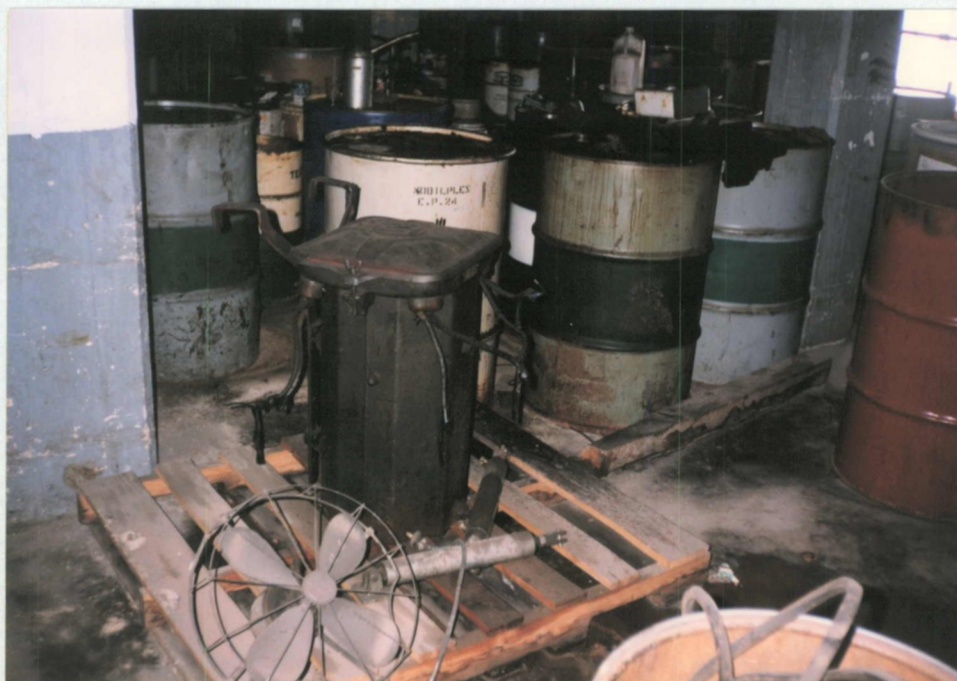
SCENE: View of single off-line electrical transformer, possibly containing oil with PCBs, located at the southwest portion of the second floor of No. 1 Storehouse, looking southwest.

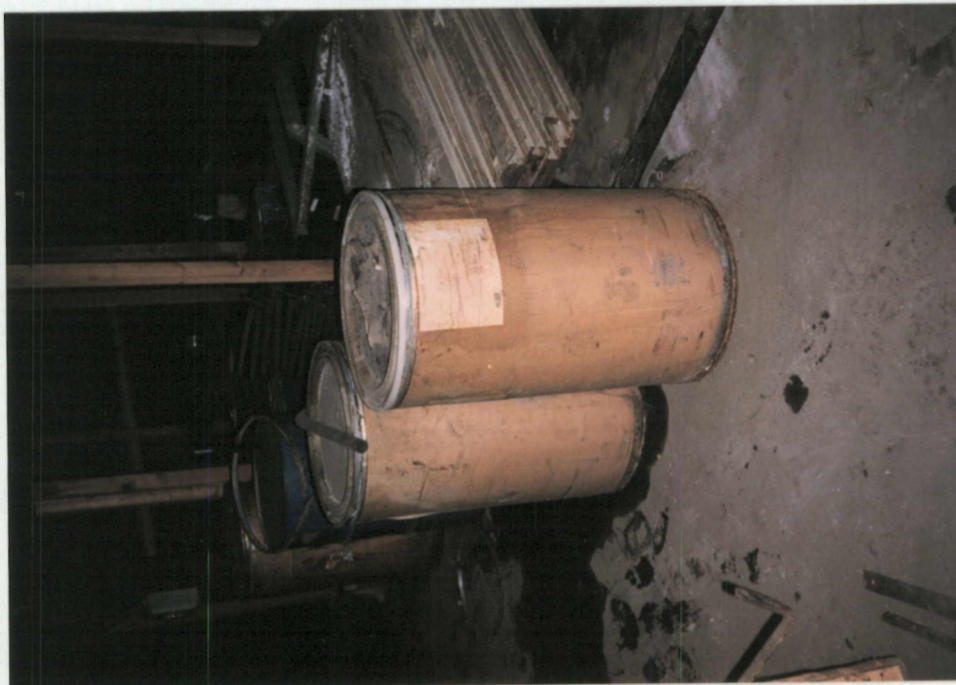
SCENE: View of miscellaneous drums located at the northern half of the third floor of No. 1 Storehouse, near the center of the room, looking northeast. One labeled as resin for zeolite water softener.

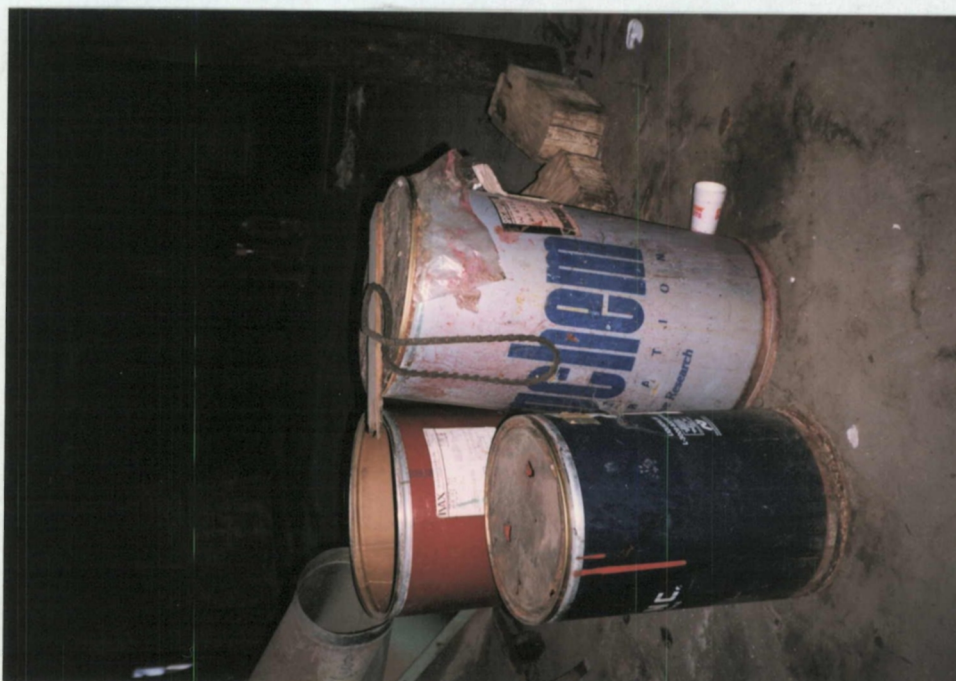
SCENE: View of miscellaneous drums, located at the western half of the third floor of No. 1 Storehouse, looking northwest, near the center of the room. Labeled as dyes and Reactex 711.

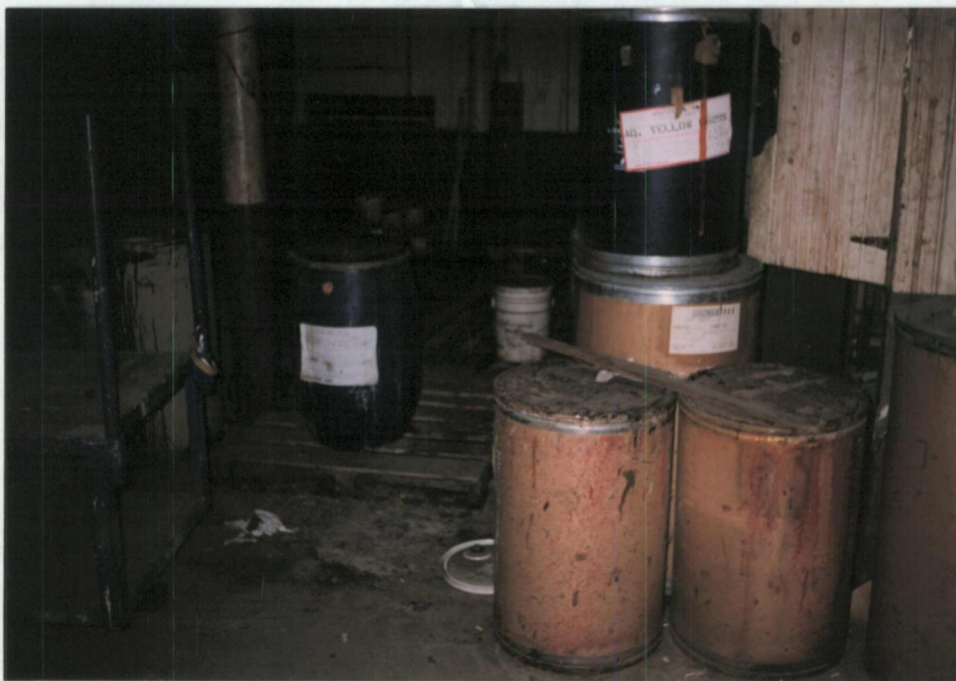
SCENE: View of miscellaneous drums located within/near the entrance to the separate room at the southwest portion of the third floor of No. 1 Storehouse, looking north. Most labelled as dyes.

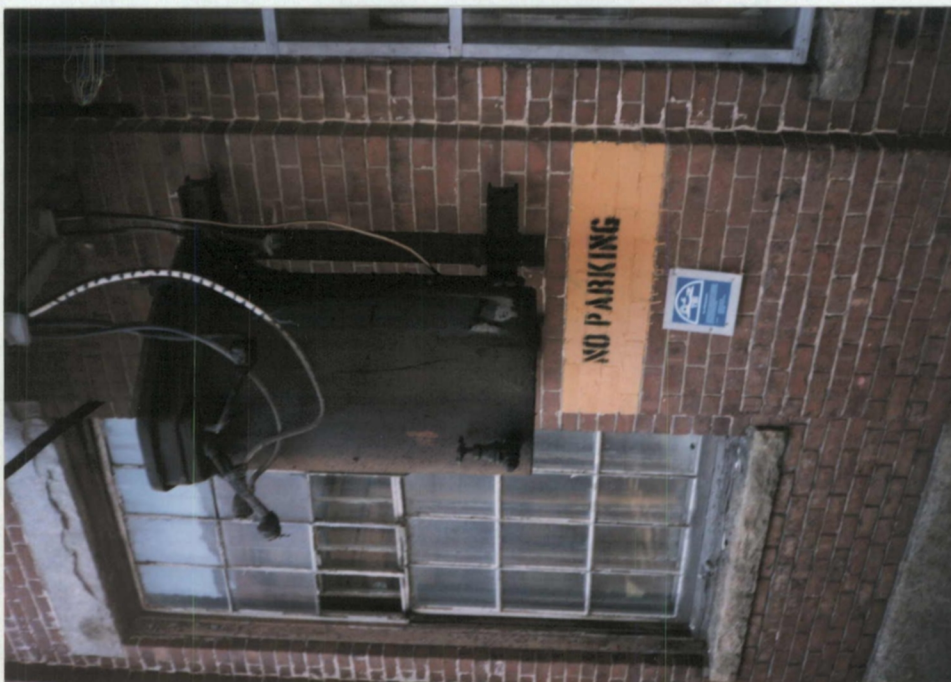
SCENE: View of a wall mounted electrical transformer possibly containing oil with PCBs, located on the outside west wall of Mill No.2, facing Mill No. 3 Annex (catch basin located beneath the transformer, not shown in picture).

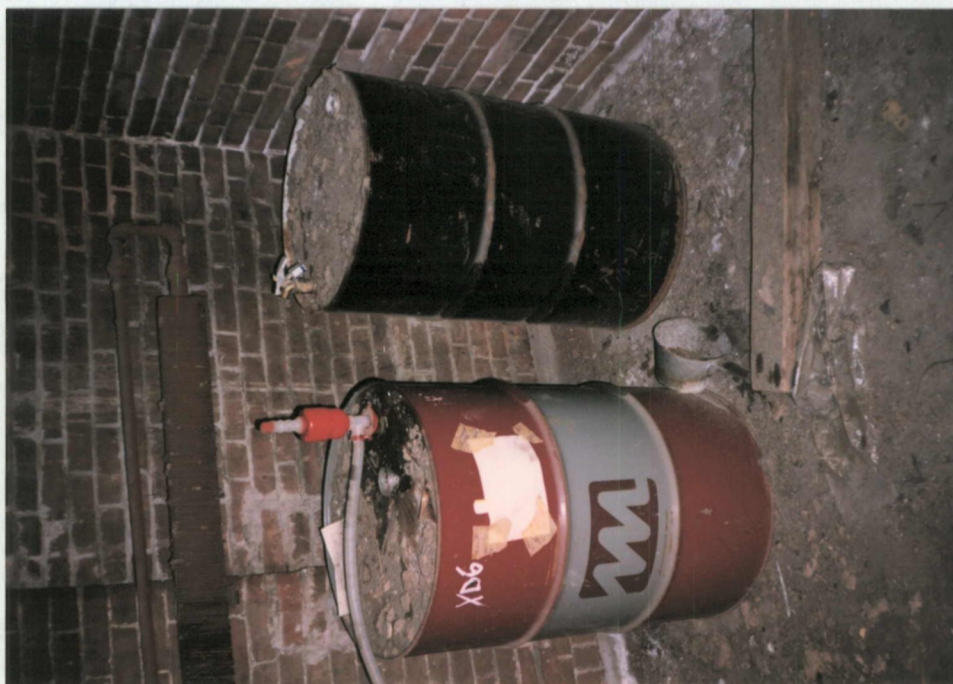
SCENE: View of sample station D-6. Two 55-gallon closed-top steel drums located in small room off of the north side of No. 2 Wing, looking south (sample station is red drum on left). Red drum on left labeled as ethyl alcohol.

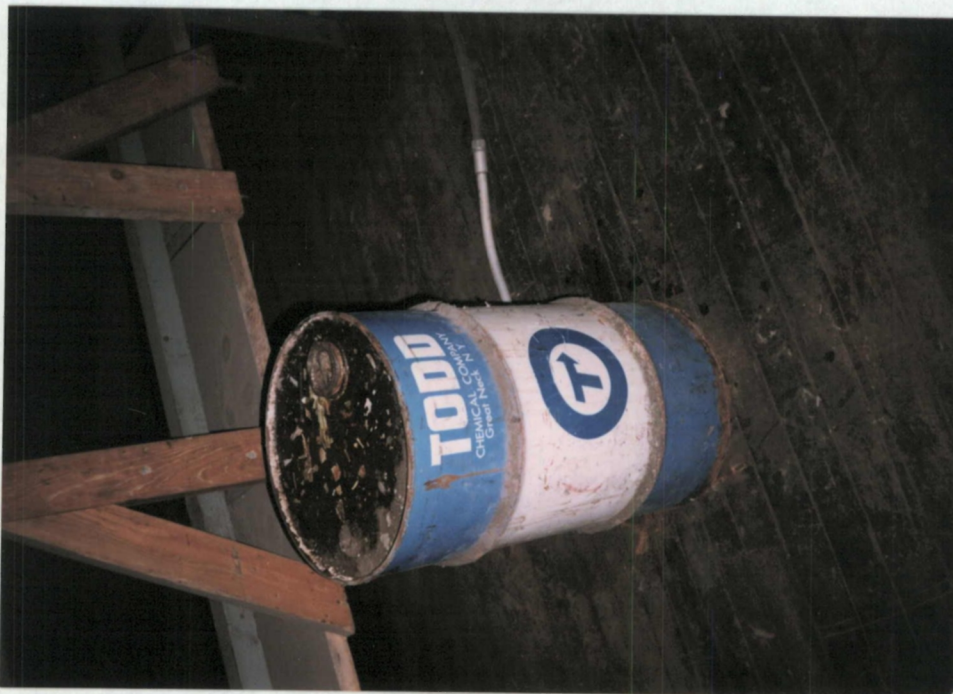
SCENE: View of sample station D-11. An approximate 30-gallon, closed-top steel drum, located along room divider wall (north side) in the southern portion of the first floor of Mill No. 2, looking south. Labeled as ammoniated nitrate cleaner.

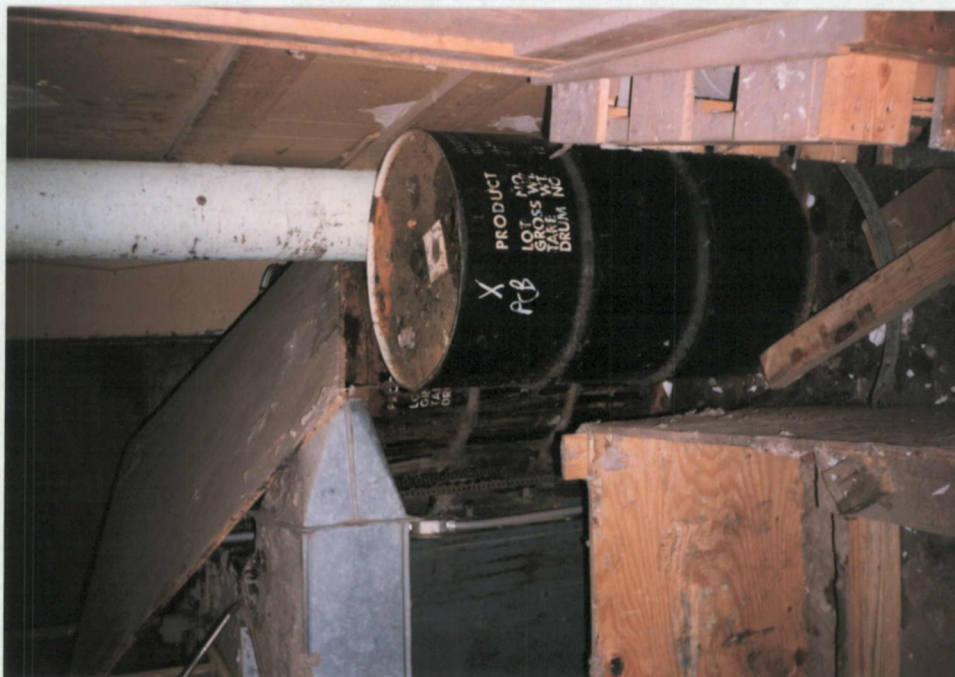
SCENE: View of sample station D-7, a black 55-gallon closed-top steel drum along the divider wall (north side) at the southern portion of the first floor of Mill No. 2, looking south.

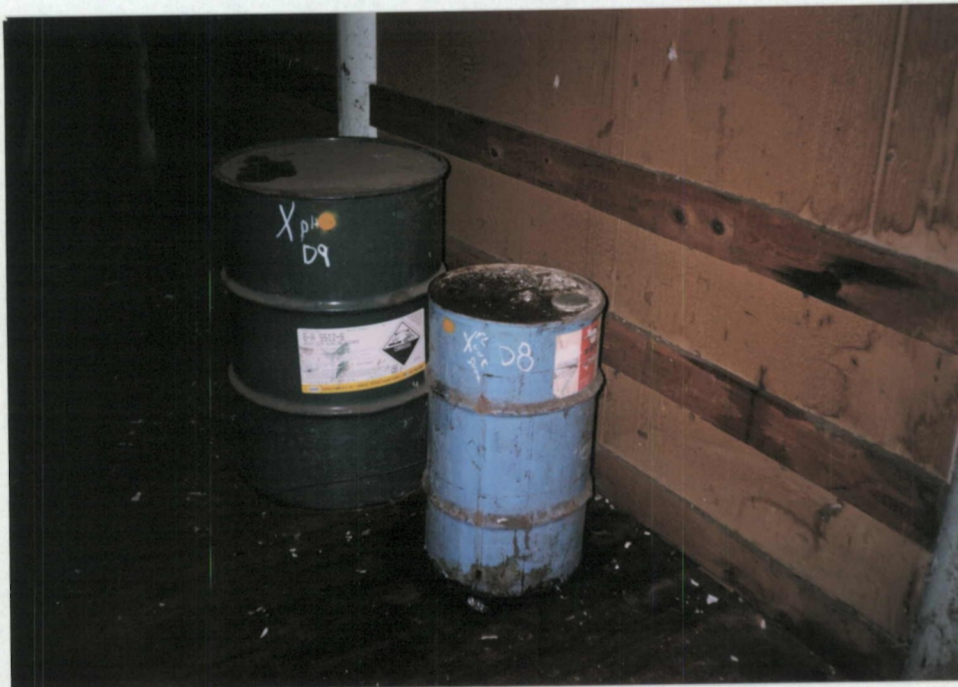
SCENE: View of sample stations D-8 and D-9. One 55-gallon closed-top steel drum and one 30-gallon drum (approximate) closed-top steel drum along outside wall of small room located on east side of the first floor of Mill No. 2. Drum on left labeled as BR cleaner.

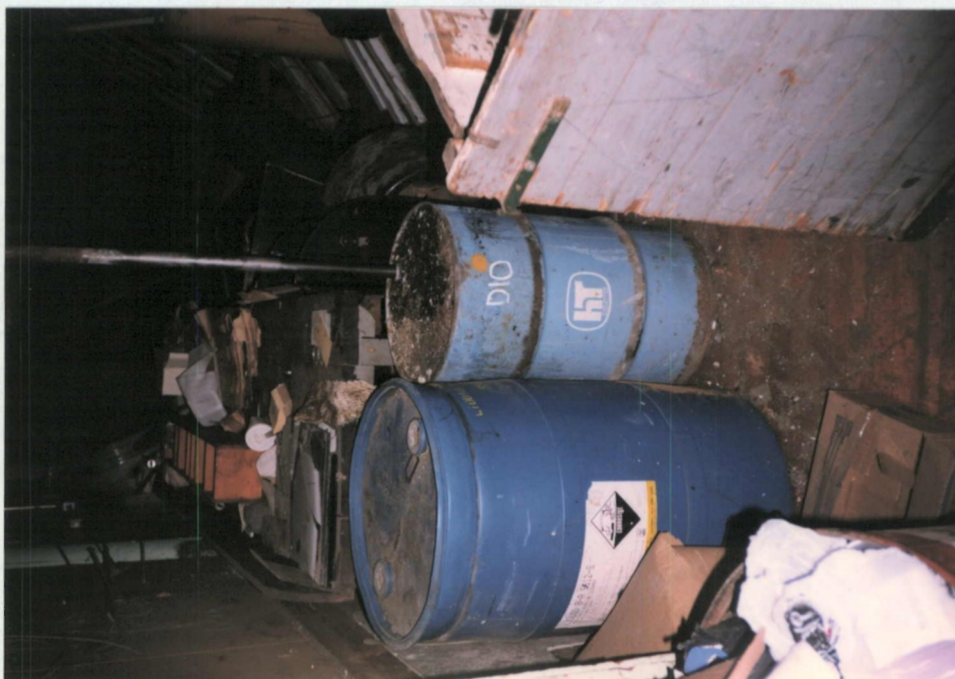
SCENE: View of sample station D-10. One 55-gallon closed-top blue plastic drum and one 30-gallon (approximate) closed-top steel drum (blue colored drum), with hand pump located in the small room along the east side of the first floor of Mill No. 2 (looking north). Drum on left labeled as heavy duty alkaline cleaner, corrosive. Drum on right labeled as weed killer.

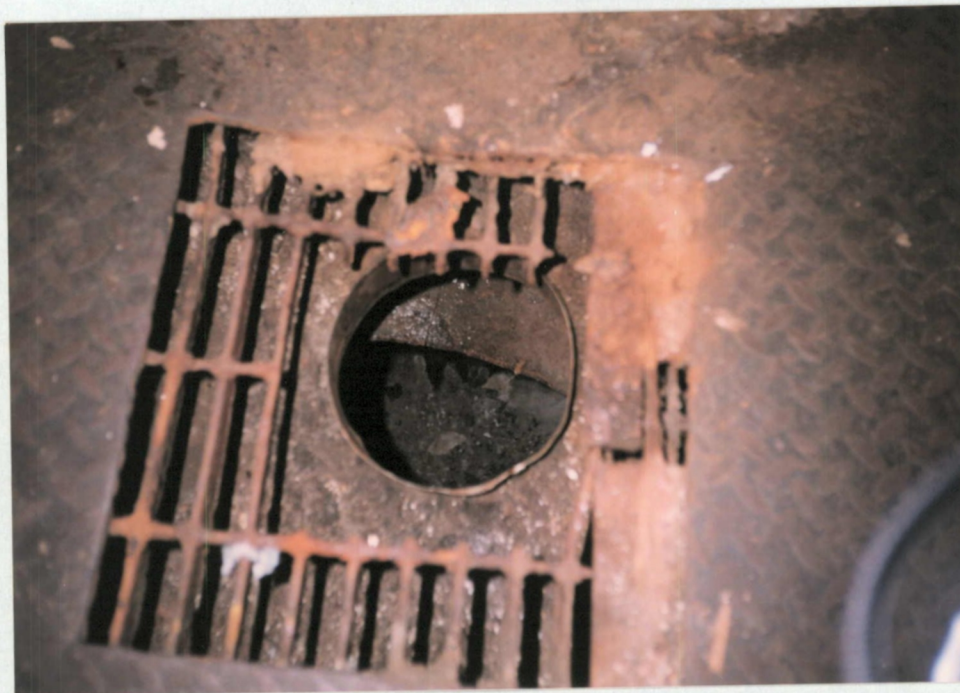
SCENE: View of sample station T-1. Access hatch opening to “railroad” tanker car No.1, an approximate 20,000 gallon AST. View is through the floor of Mill No. 4/Bleachery (easternmost of two “railroad” tanker cars).
